#### Case Report

# Explosion and Fire Caused Due to Storage of Maleic Anhydride and Potassium Hydroxide Together

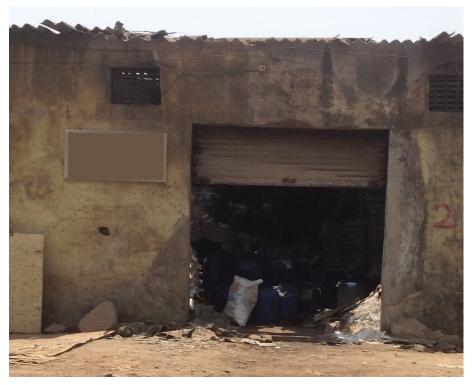
The fire affected warehouse was facing north (Figure 2). Extensive burning was observed on north western side of the warehouse i.e., zone 8 and 9. The asbestos roof above the chemical bags stored there, was found to be blown off (Figure 3) and the bags

Figure 2: The front view of the fire effected warehouse

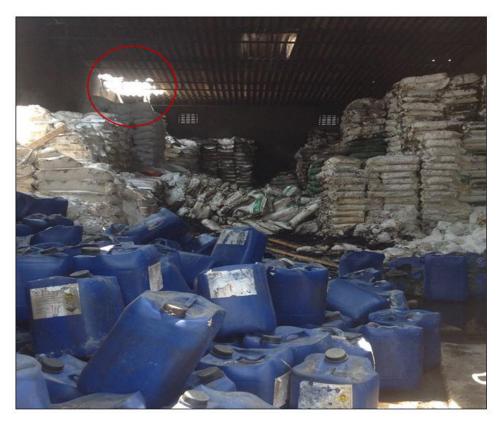
were burnt/ fused to various degrees. Further, the effect of fire was found to be maximum in zone 8 and 9 (Figures 3 and 4). From the examination of the records and interaction with ware-

**Figure 3:** An overview of the fire effected warehouse showing the blown off roof over the area where maleic anhydride was stored indicating a low intensity explosion.

As the maximum damage occurred in zones 8 & 9 which extended to the adjoining zones 10 & 15 and the fact that the roof made up of asbestos sheets above zone 9 and zone 15 were blown off, indicates a low intensity explosion. As per ware house keeper, in zones 8 & 9, 200 bags (of 50 kg) of potassium hydroxide (Caustic potash) and 800 bags (of 25 kg) maleic anhydride were stored. All the bags were totally fused or burnt. Hence it is inferred that the fire originated from this area i.e., zone 8 & 9.

Due to the explosive force, the roof of the ceiling was blown off over zones 9 and 15 (Figures 3 and 5). The fire generated in the explosion burnt/fused all the 800 bags of maleic anhydride, 200 bags of potassium hydroxide and 480 bags of sodium sulphate stored in zones 8, 9 and 15. The fire so generated spread to the neighboring zone 10 where sodium carbonate (Soda ash) stored was also found fused.

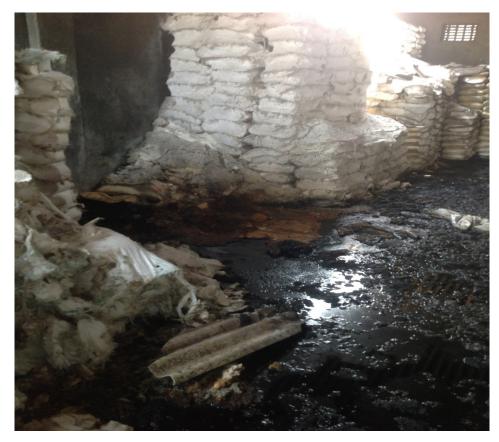
house keeper, it was found that 200 bags of potassium hydroxide (Caustic potash) and 800 bags of maleic anhydride were stored side by side in these zones 8 and 9 respectively.

Figure 4: A view of the area after the incident of fire where the 200 bags of potassium hydroxide stored was completely burnt

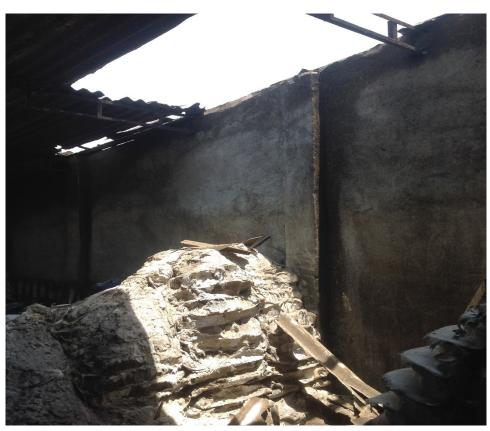
Some of the bags of sodium carbonate (Soda ash) stored (adjacent to zones 8 and 9, towards northern side) in zone 10 were also found fused. All the 480 bags of sodium sulphate stored in zone 15 (Figure 5), adjoining the completely affected zones 8 & 9, towards the eastern side were also found fused. The asbestos roof above this zone was also found to be blown off.

Figure 5: A view of fused Sodium Sulphate bags. The blown off roof due to low intensity explosion can also be seen in the figure

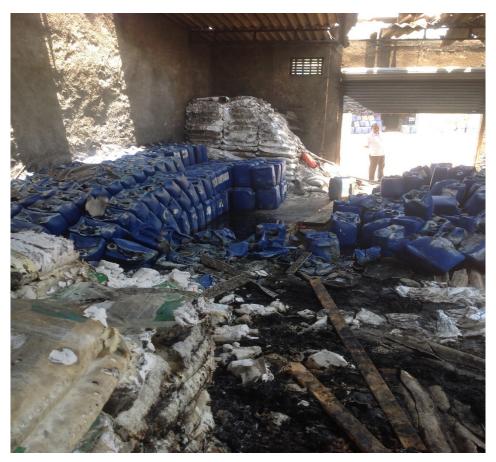
The sodium sulphate stored in zone 1 & 12 was marginally affected by fire. The hydrogen peroxide cans stored in zones 2 & 13 were partially damaged due to fire (Figure 6). The bags of trisodium polyphosphate, in zone 3, sodium sulphate stored in zones 4, 5 & 6 were partially affected. Sodium sulphate stored in zone 7 was also partially fused. Potassium carbonate in zone 11 and some bags of sodium carbonate (Soda ash) stored in zone 10 were marginally affected by fire (Figure 7). Borax stored in zone 17 & 14, bleaching powder in zone 16 were marginally affected by fire.

Figure 6: A view of the partially effected Hydrogen Peroxide cans stored away from the origin of fire

Among the remaining chemicals stored in the warehouse, bleaching powder [16] and hydrogen peroxide [17] are known to be reactive and cause explosions and fire under certain conditions. However, as these were stored in zone 16 and zone 2 & 13 respectively far away from the origin of fire and were partially affected by fire, their role in causing the fire accident is ruled out. The remaining chemicals are stable and non-flammable; they were partially affected due to external fire. The storage conditions of both potassium hydroxide and maleic anhydride stipulate that they have to be stored in cool, dry, well-ventilated area away from each other. However, in the instant case, potassium hydroxide and maleic anhydride were stored side-by-side in relatively hot environment without any proper ventilation, violating the basic storage criteria.

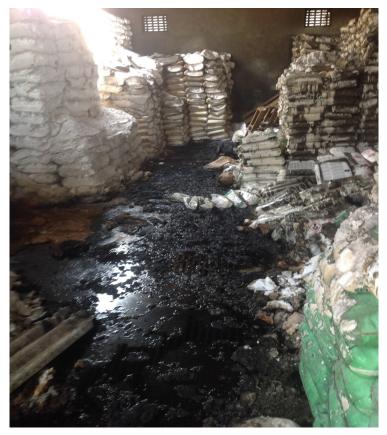
**Figure 7:** A view of the marginally fire effected potassium carbonate and sodium carbonate bags stored far away from the origin of fire
